ENGINEER'S REPORT

JULIE SPRAFKA INJURY

INVESTIGATION OF THE JULIE SPRAFKA INJURY

ENGINEERING REPORT

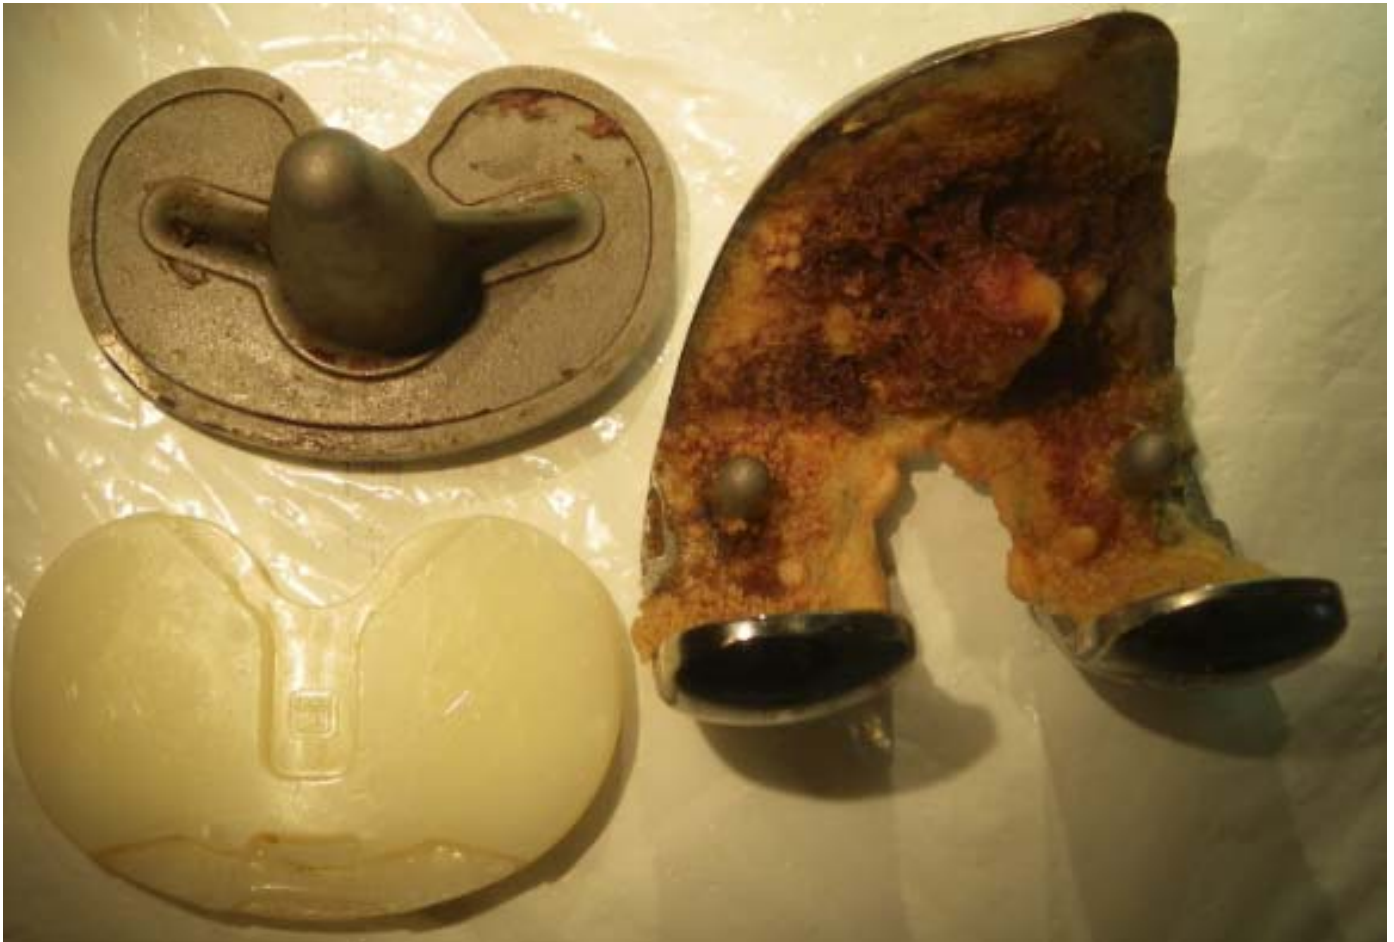
Figure 1: Group photograph of the three Attune TKA devices explanted from Julie Sprafka on October 15, 2020. **Upper Left**-Tibial baseplate. Some biologic debris is noted. Cement is not adherent to the majority of the visible surface. **Lower Left** - AOX Ultra high molecular weight polyethylene(UHMWPE) with tibial liner. Baseplate locking surface is seen. **Right** - Bone-contacting surface of the femoral implant, bone cement remains attached to the CoCr surfaces. Biologic material/blood is visible on the cement surface.

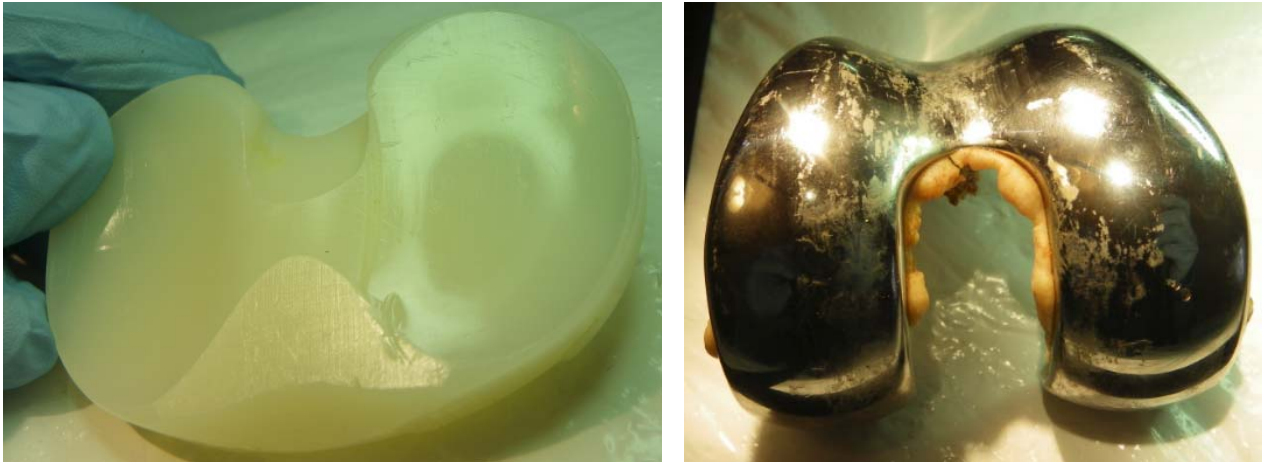
Figure 2 : The bearing surfaces of Ms Sprafka's explanted knee implant are shown. **Left** - UHMWPe liner, **Right** - Femoral condyles.

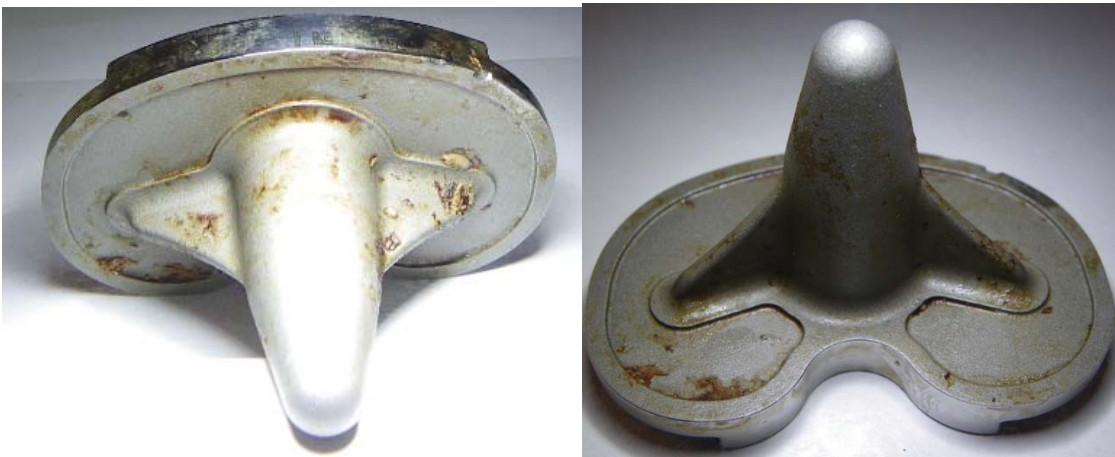
Figure 3: Images of Ms Sprafka's explanted Attune tibial baseplate undersurface. The majority of the surface has no retained bone cement. A smooth blast surface finish is seen on the shallow cement pockets and keel region.

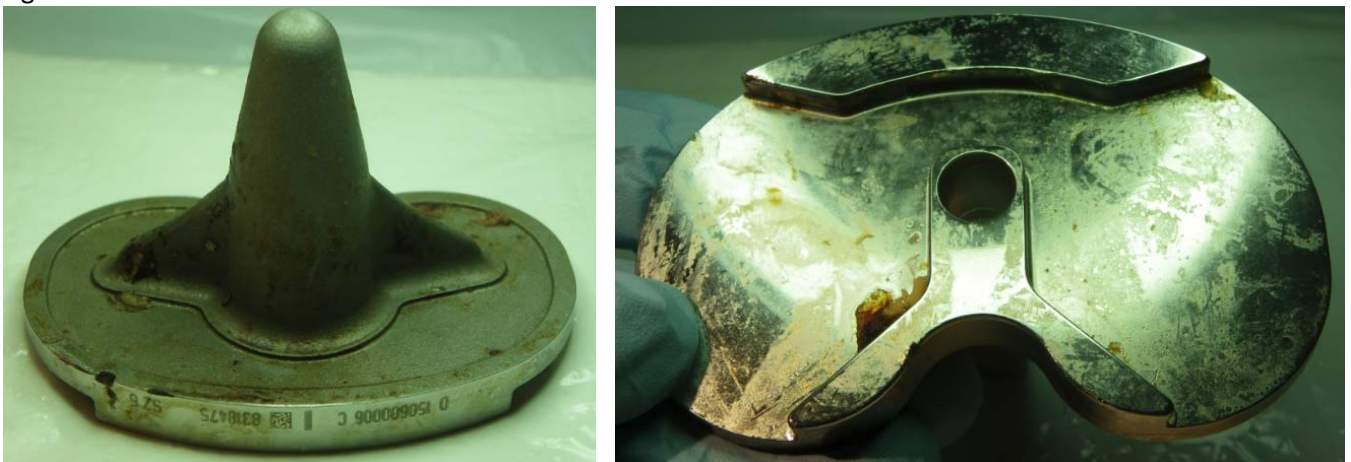
Figure 4 : Images of Ms Sprafka's explanted Attune tibial baseplate showing the part number (left image) and the baseplate bearing bearing snap-lock attachment surface (right image).

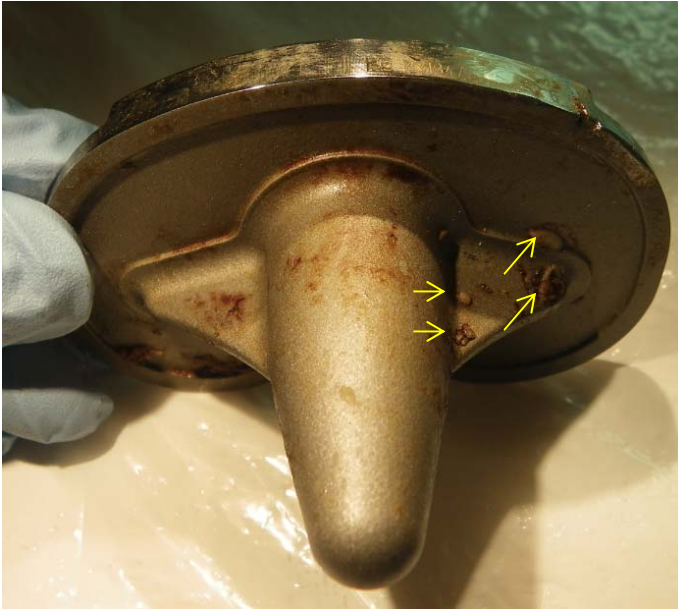
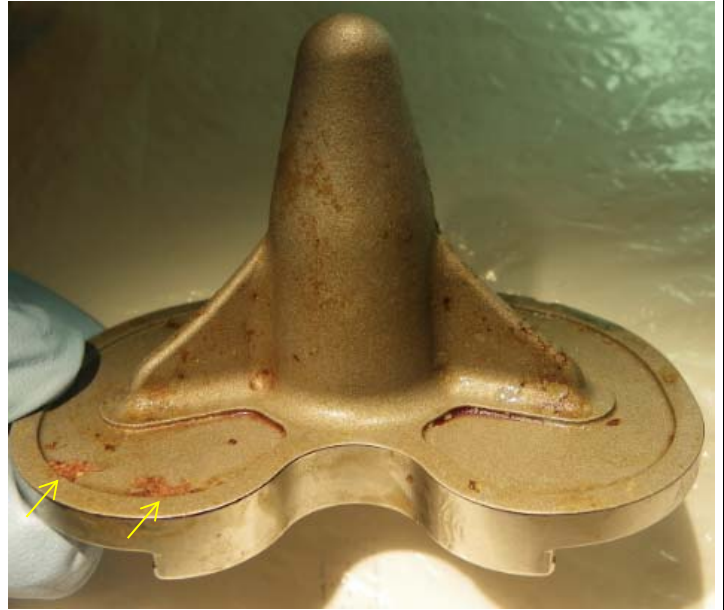
Figure 5: More images of Ms Sprafka's explanted Attune tibial baseplate undersurface. The majority of the surface has no retained bone cement. A smooth blast surface finish is seen on the shallow cement pockets and keel region. Both regions have biologic debris and are essentially devoid of cement. Small zones of bone cement covered with biologic debris were identified near the posterior perimeter and on a keel.

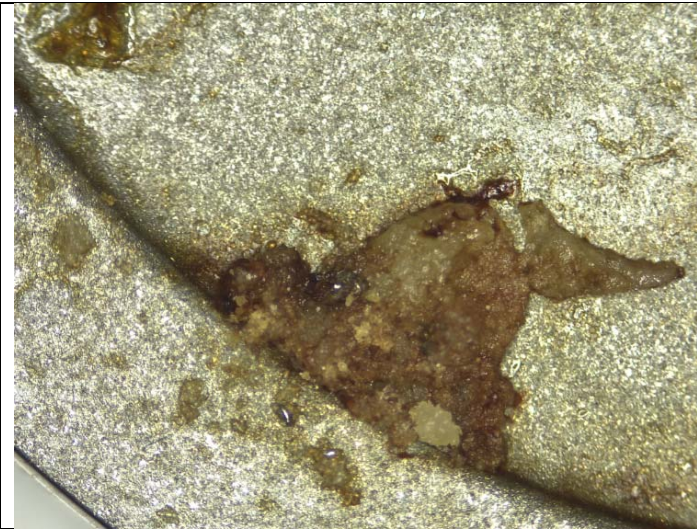
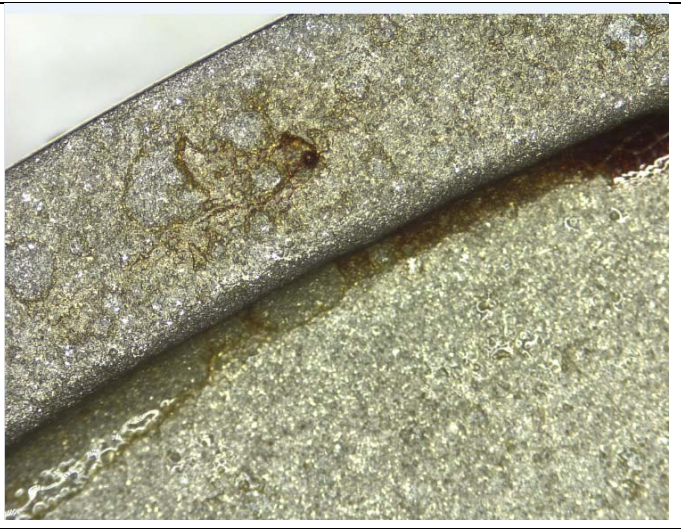
Figure 6: Left - This image shows one of the perimeter locations with a bone cement fragment. Right- This image shows the typical appearance of the tibial baseplate implant at the perimeter. Biologic residue is still present.

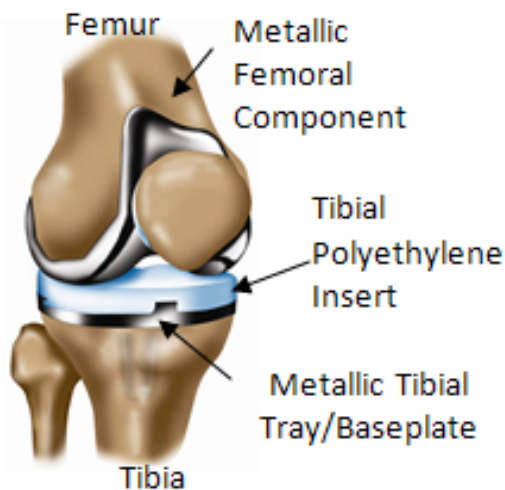
Figure 8a: Cruciate retaining (CR) knee implant (no posterior stabilizing post or housing). A standard liner constraint is shown in this image. There is no post or housing to interact in the center of this implant.

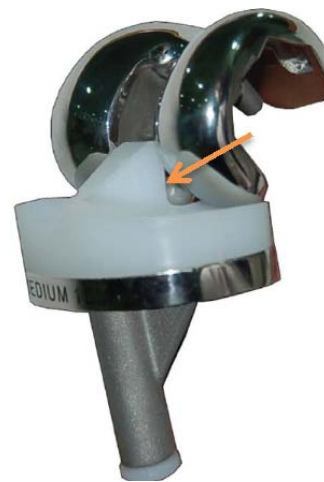
Figure 8b: PCL sacrificing posterior stabilized knee implants (PS knee implants). Orange arrow points to the stabilizing post tibio-femoral implant interaction, which assures some roll back.

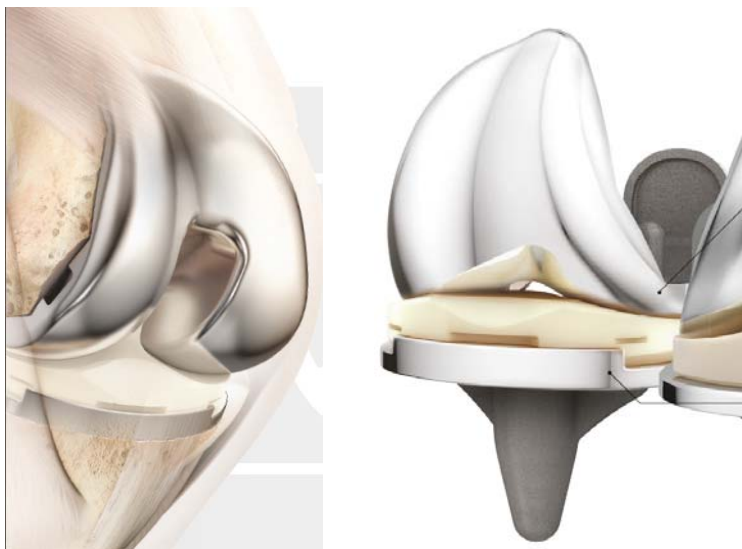
Figure 9: Two images of the Attune Knee CR knee assembly showing a CR femoral implant, a CR tibial polyethylene liner and a tibial baseplate as shown in the company brochure DSUS/JRC/0514/0162. The image of the left depicts a right knee implanted in transparent bon and tissues. The knee is in a flexed position. The image on the right shows similar left CR knee components oriented in extension, without any transparent bone or soft tissue.

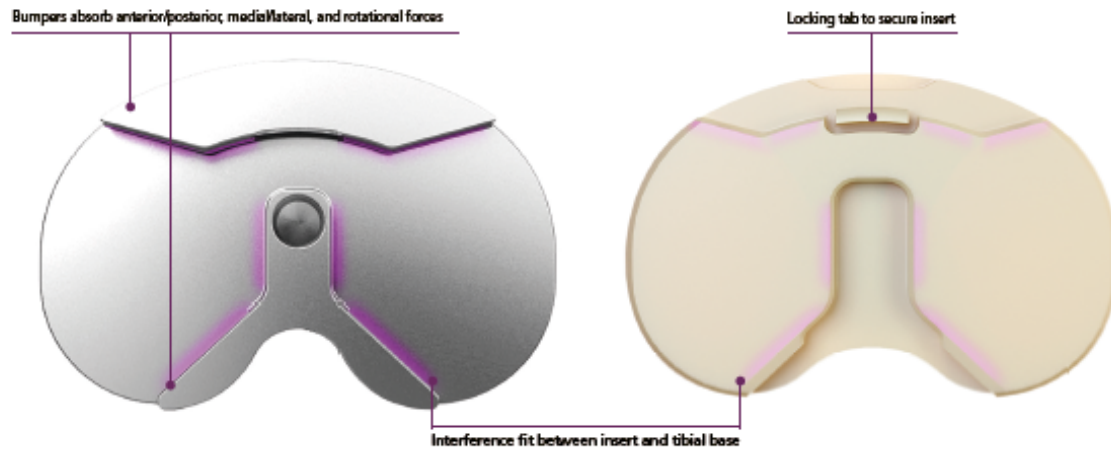
Figure 10: Images of the Attune Knee tibial baseplate and mating polyethylene liner locking features as shown in the company brochure DSUS/JRC/0514/0162.

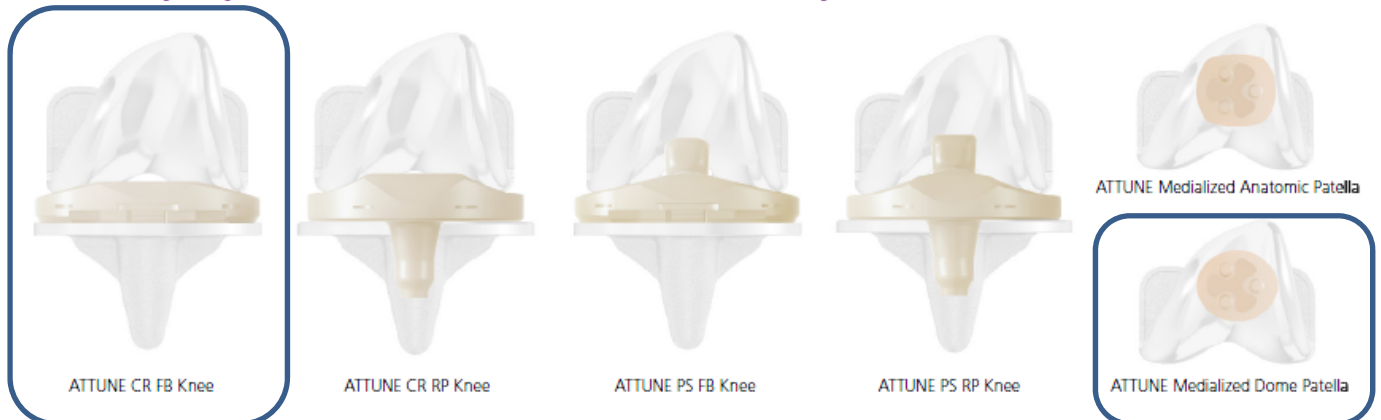
Figure 11: Images of Attune AOX Polyethylene liners as shown in DSUS/JRC/0714/0314 Attune Knee System AOX Antioxidant Polyethylene brochure. Julie Sprafka was implanted with the device types circled in blue.

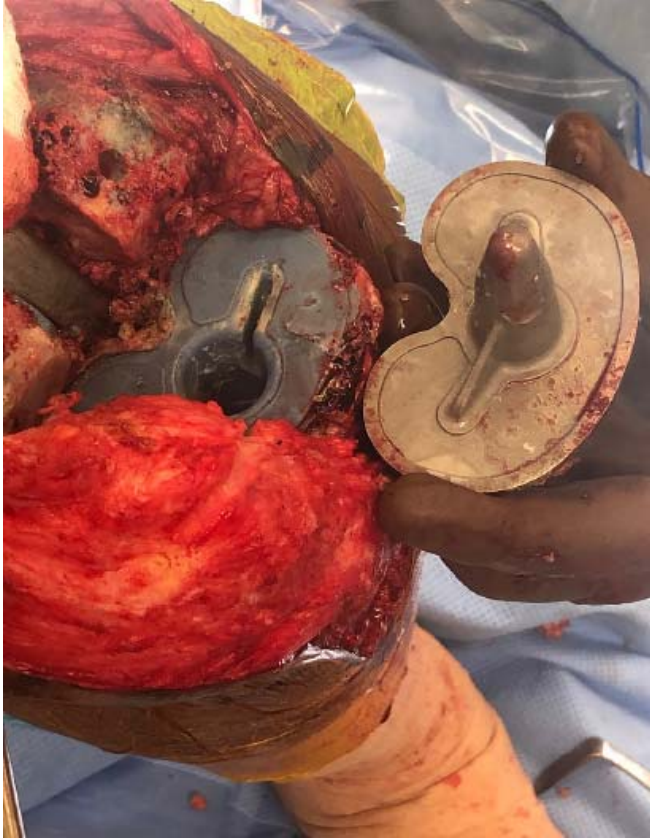
Figure 13: Image from literature (Murphy et al¹) depicting a debonding failure similar to Julie Sprafka. The intraoperative photograph of a right knee demonstrating cement mantle interdigitated to the proximal tibial surface without adherence to the undersurface of the Attune tibial baseplate.

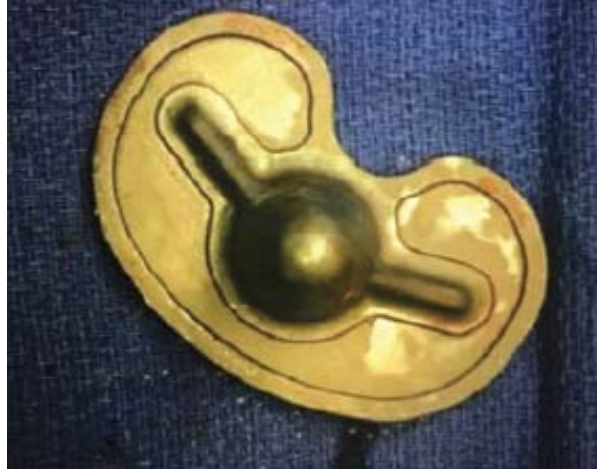
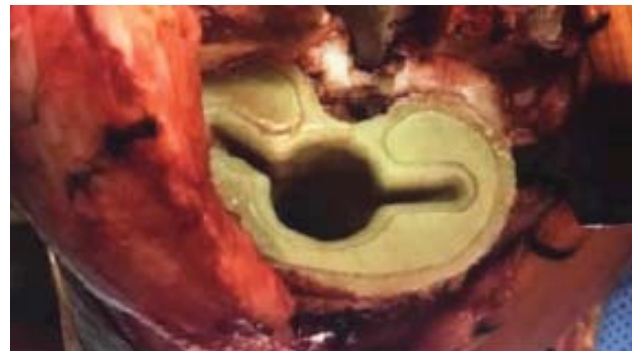
Figure 14: Image from literature (Bonutti et al²) depicting a debonding failure similar to Julie Sprafka. The intraoperative photograph of a right knee showing an intact cement mantle adherent to the proximal tibial surface without adherence to the undersurface of the Attune tibial baseplate.

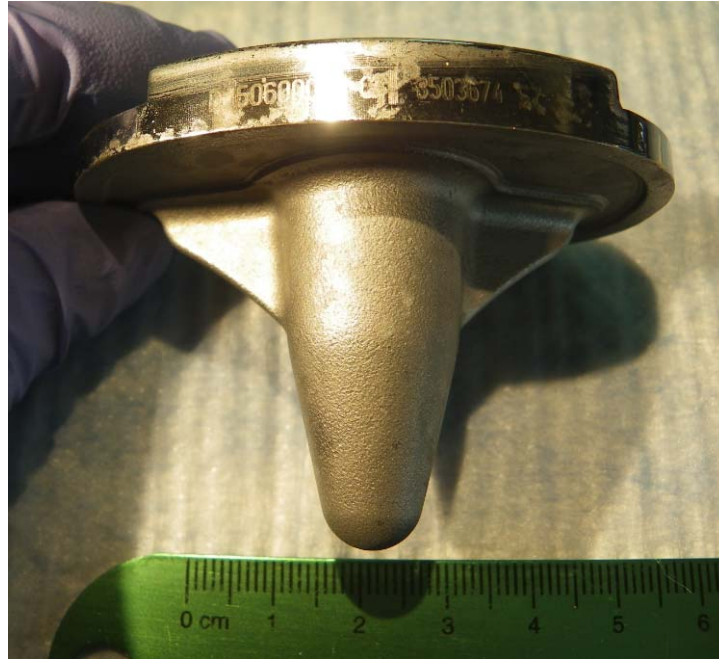
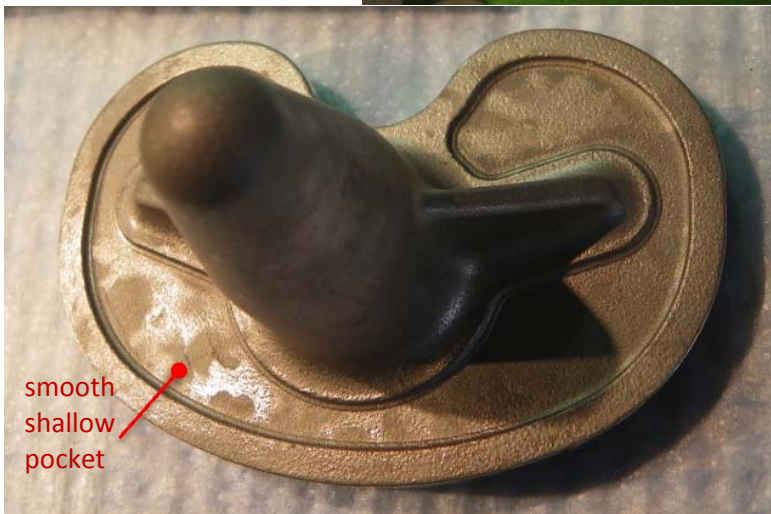
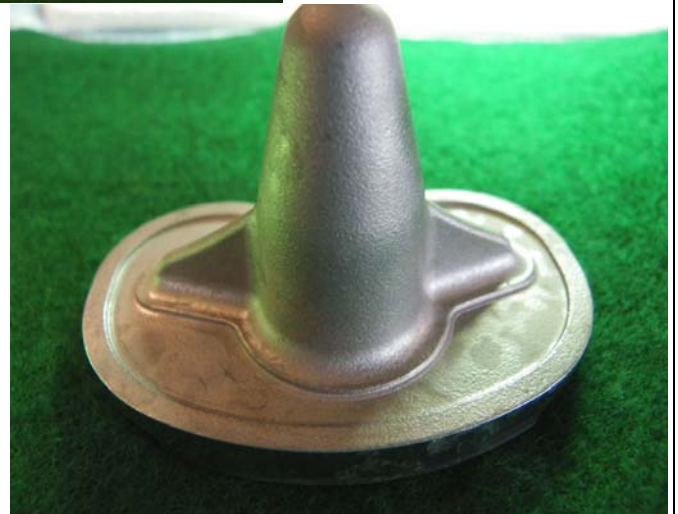
Figure 15: Photographs of an explanted size 3 Attune tibial baseplate, which I inspected (from another patient). The bone cement used in that patient was Zimmer Palacos R. Macroscopically, there is no appreciable bone cement attached to the undersurface of the tibial baseplate including the stem and keel region. The cement pocket is roughly 0.5 mm deep (below the perimeter). The edges of the pocket are radius'd. This increases part strength but reduces cement resistance to shear. (*The cement interface surface was viewed macroscopically and using a stereoscope.*) In that case the cement also remained adherent to the tibial bone after explanation of tibial component. The production prints for Attune backside and stem specified tumble followed by a 60 grit blast finish with a R_t 7 min.[DEPATT 00219223/242]^F

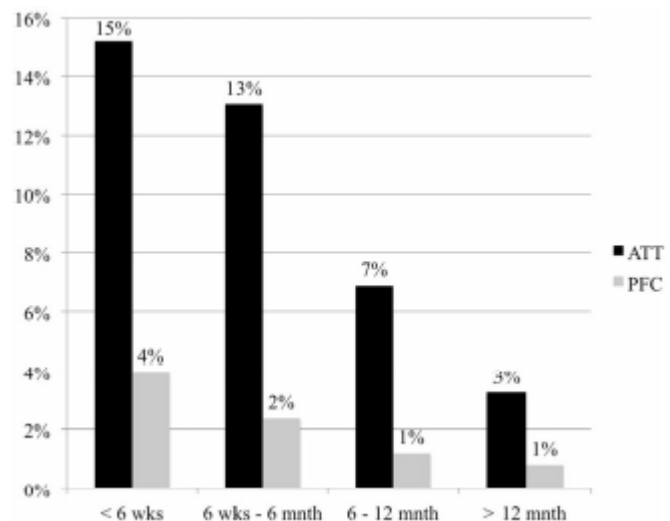
Figure 16: Incidence of radiolucent lines depending on the date of first detection for Attune (ATT) and PFC. In the Attune 40.8% of all radiolucent lines were detectable in the immediate postoperative radiograph (< 6 weeks postoperatively), whereas only 19% ($n = 4$) of all radiolucencies in the PFC-group were visible directly after surgery. In total radiolucent lines were detectable in 37.3% of the ATT-group and in 8.3% of the PFC-group. (Staats et al¹⁸)

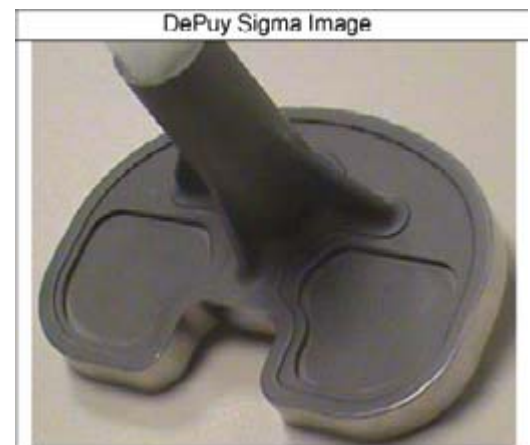
“Cemented tibial components have undercut medial and lateral cement pockets to enhance pressurization and produce a peripheral implant to cement interlock. This seals the fixation interface and protects it from particulate debris. The cruciform keel design assures optimal rotational stability and avoids anterior rocking force. The porous coated option has extensive Coating to the fixation interface, but none to the keel.”

Figure 17: Image of one style DePuy Sigma Tibial Baseplate.

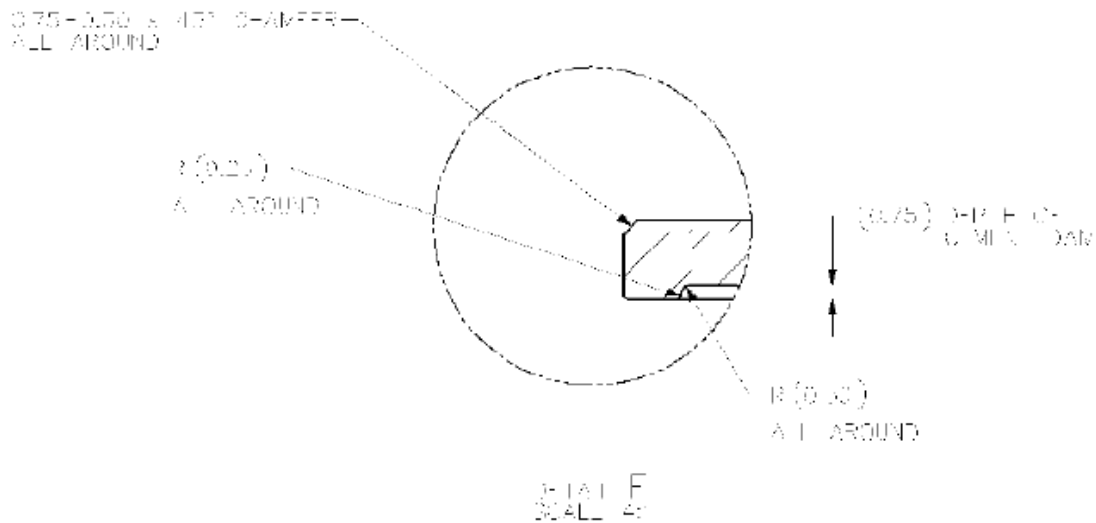
Figure 18: Image showing pocket depth in a rotating platform bearing tray.
[DEPATT_00219278/296]

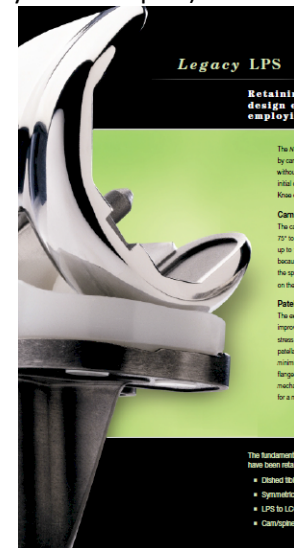
Figure 20: (Above) Nexgen Legacy tray with long Keel and cement pockets. Zimmer brochure 97-5970-01 ©2002 Zimmer Inc. Note that many of Zimmer's cemented devices feature a precoat of PMMA.

Many cemented tibial implants in the early 1990s featured cement pockets which were $\geq 1\text{mm}$ in depth. Some pockets features keyseat or dovetail undercuts. Other implant surfaces were covered with plasma spray or porous coatings, or at least a coarse grit blast finish with the coarsest surface being generated using a 12 or 16 mesh grit on a Ti6Al4V surface ($R_a \geq 8\text{-}12$ microns), and the least rough being generated with a size 24 grit. Keels or spikes in addition to a central stem were common to mitigate shear forces.

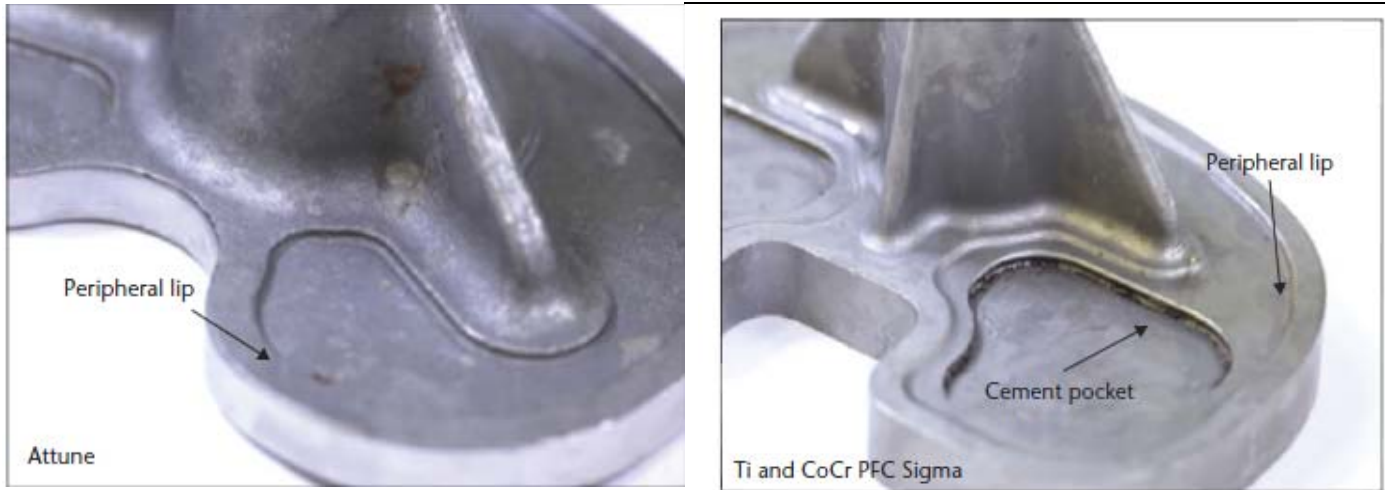
Figure 21: Detailed examples of lips and undercuts found in retrieved Attune and PFC Sigma tibial baseplates as reported in Cerquiglini et al⁷¹. Deeper deeper cement pockets with dovetail undercuts are visible in the PCF Sigma, a predecessor to the Attune product.

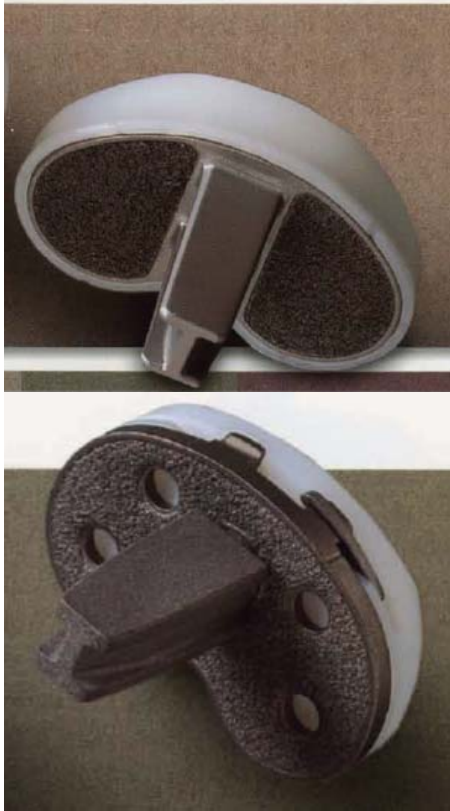
Figure 23a: (Left) AGC and Vanguard TKA knee tibial tray undersurface circa 1995. [Source Biomet brochure No. Y-BMT-439_061595©1995]

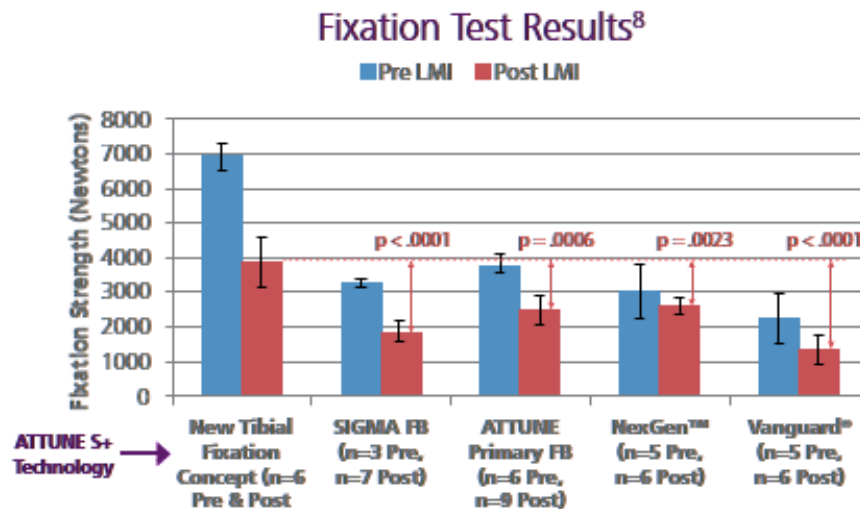
Figure 24: Pull-off (tensile force retention) data from a DePuy Brochure. "Attune knee system. Advancing Innovation with the Attune S+ Technology." DSUS/JRC/0617/2207 08/17 ©DePuy Synthes 2017.

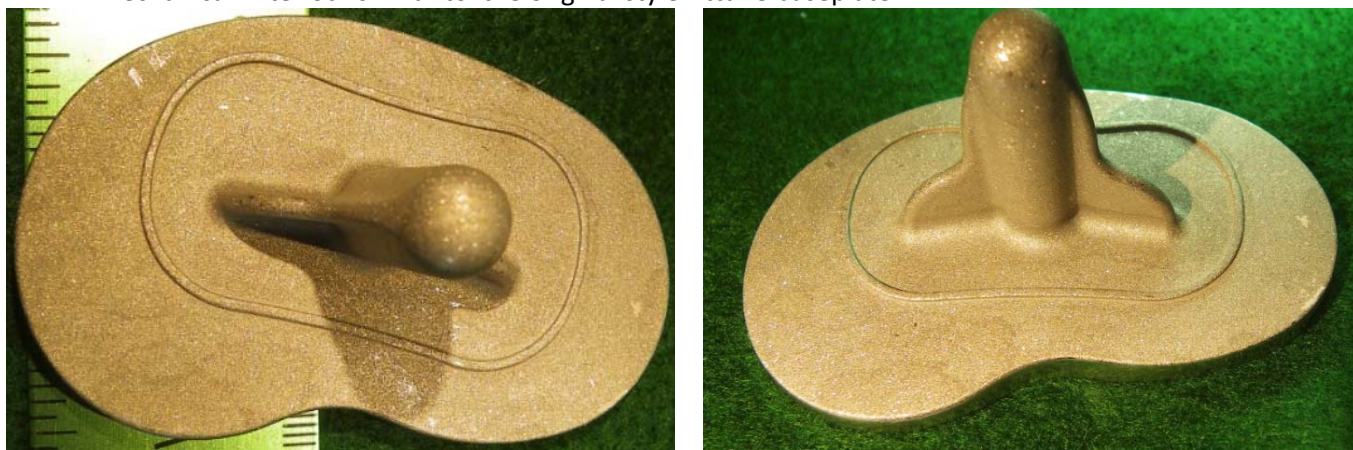
Figure 26: Undersurface of an explanted Conformis CoCr tibial baseplate. The radius'd ring was maximally 0.5 mm high. Only a couple very tiny (1 mm) zones of PMMA bone cement macroscopic are visible on the tray. Tiny zones of PMMA flecks may be present. (The cement interface surface was viewed macroscopically and using a stereoscope.)

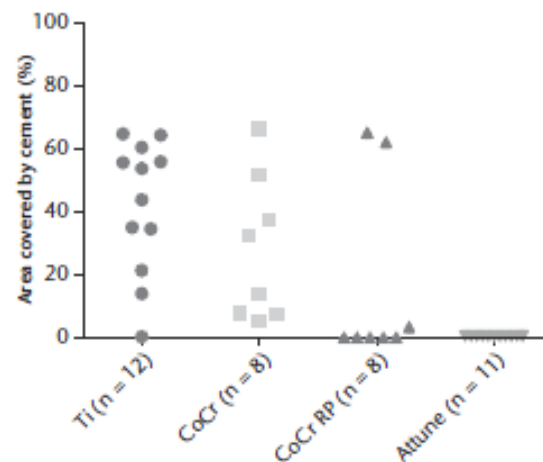
Figure 27: Retrieval Analysis of the Attune vs PFC tibial tray backsides. Graph showing the percentage of area covered by cement in the four designs analyzed. The difference between the Attune and the old PFC Sigma designs (titanium (Ti) and cobalt-chromium (CoCr)) was significant ($p < 0.05$). RP, rotating platform.¹⁰⁰ Design features analyzed by visual inspection: undercuts or cement pockets, peripheral lips, tibial tray thickness, and stem length.

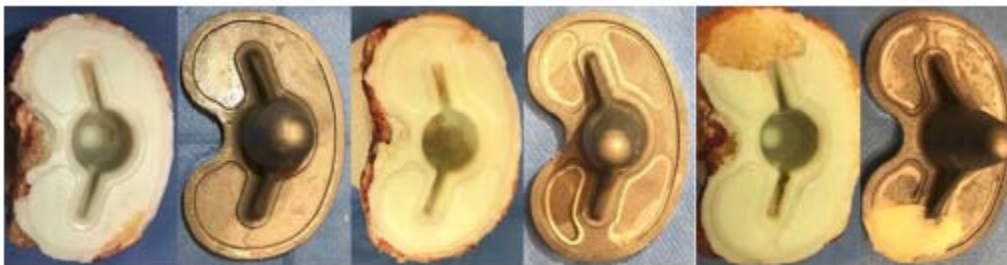
Figure 31: Left two images: Attune. Centre: Attune S+ without significant areas of adherent cement. Right: Attune S+ with adherent cement (Jaeger et al¹²¹).

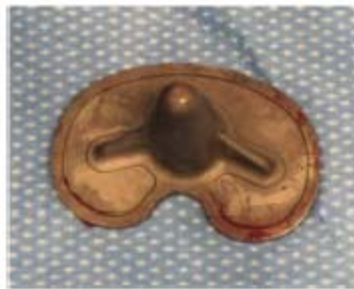
Figure 32a: Intraoperatively removed debonded tibial component (Sadauskas et al¹²⁴)

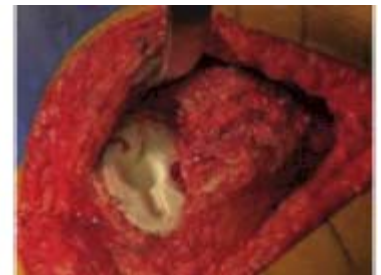
Figure 32b: Fully debonded tibial component in vivo. (Sadauskas et al¹²⁵)

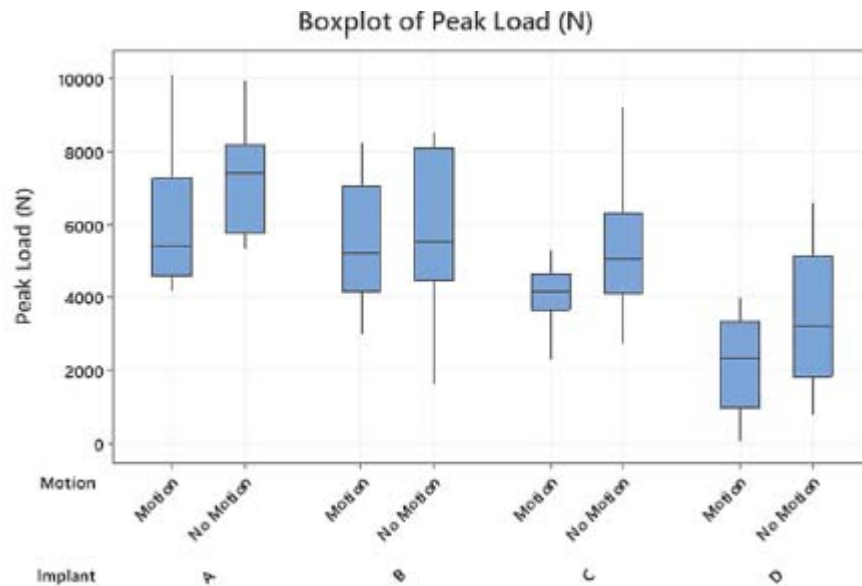
Figure 33: Boxplot of peak load (N) by implant and motion. (Martin et al¹³¹2022)

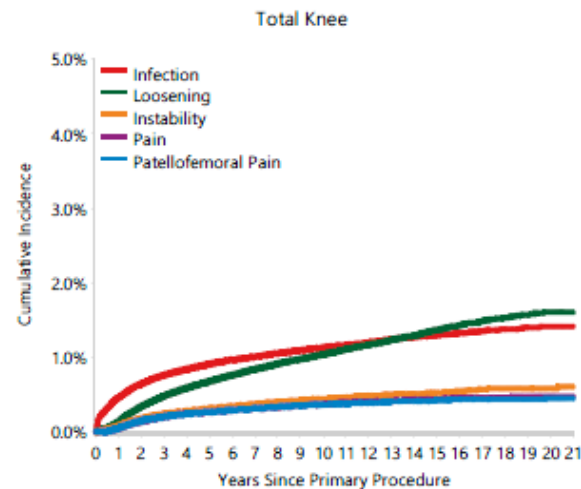
Figure 35: AOANJRR 2022, Figure KT8, Cumulative Incidence Revision Diagnosis of Primary Total Knee Replacement (Primary Diagnosis OA)

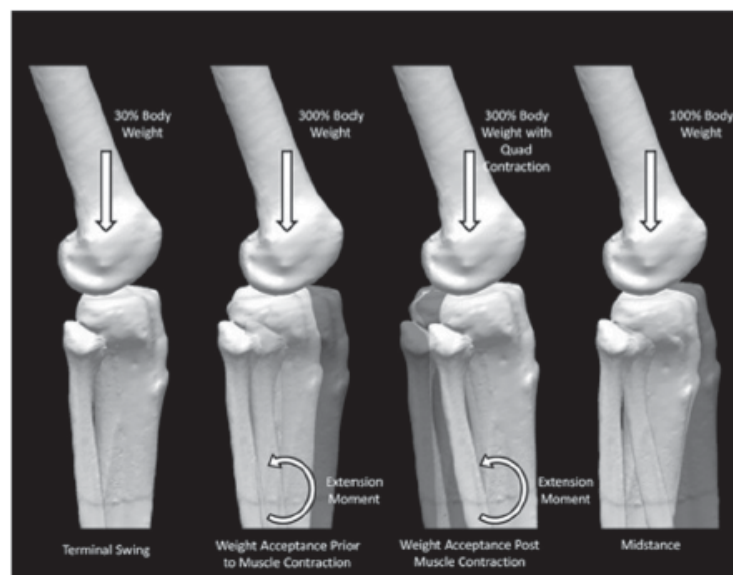
Figure 41: The phases of stair-descent as simulated during experimental testing.¹⁷⁵

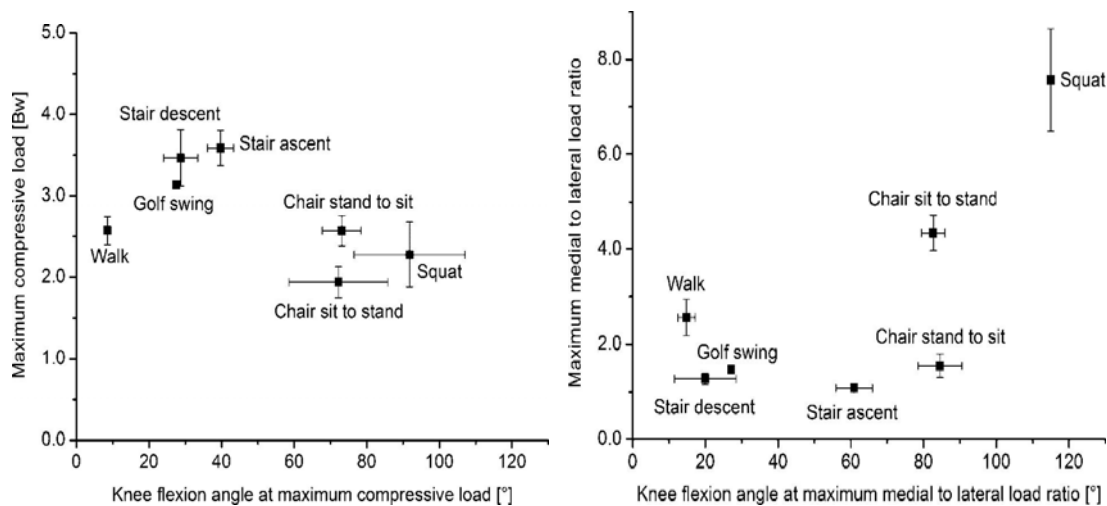
Figure 43: Measured tibial forces from the work of Mündermann et al.¹⁹¹ showing variations in load magnitude and media to lateral load shifts for different common activities

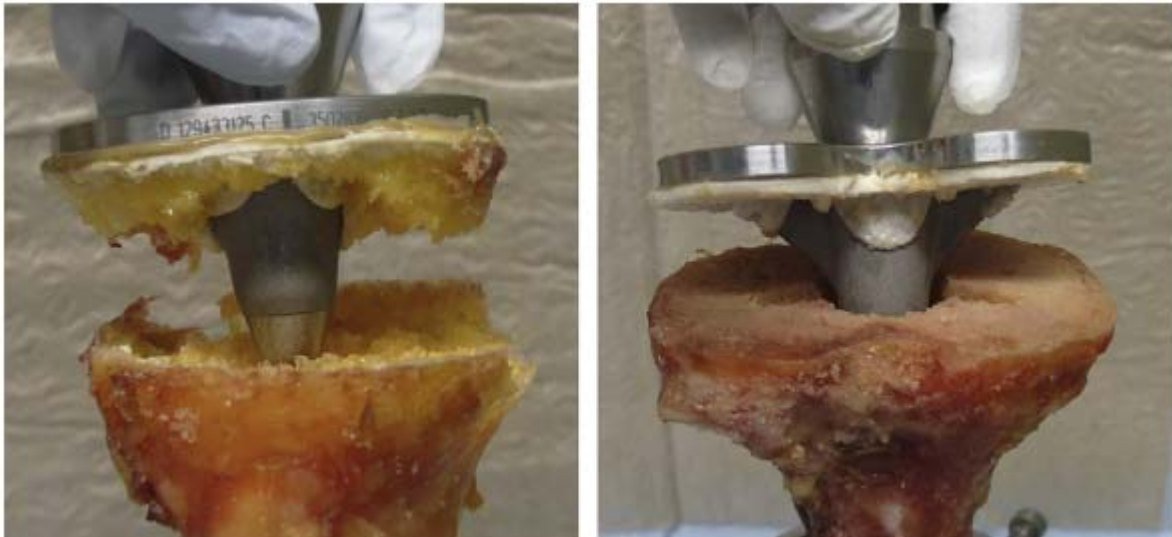
Figure 45: Specimens failing in the BULK bone (left, n = 13) or at the cement-bone INTERFACE (right, n = 10) were analyzed by Nagel et al.¹⁹³

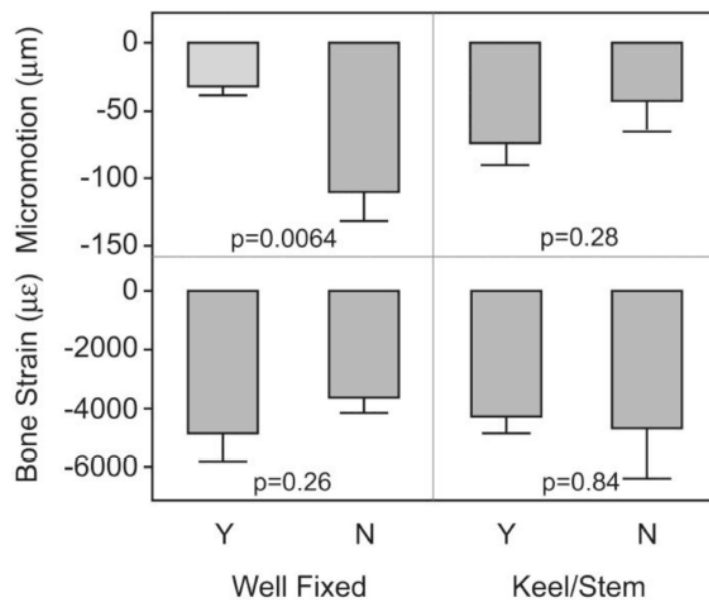
Figure 48: Data from the work of Zimmerman et al.²²⁸ Total micromotion and proximal bone strain at 6 BW loading stratified by radiographic fixation status and presence of a keel or stem. P values from two sample t-tests are shown.

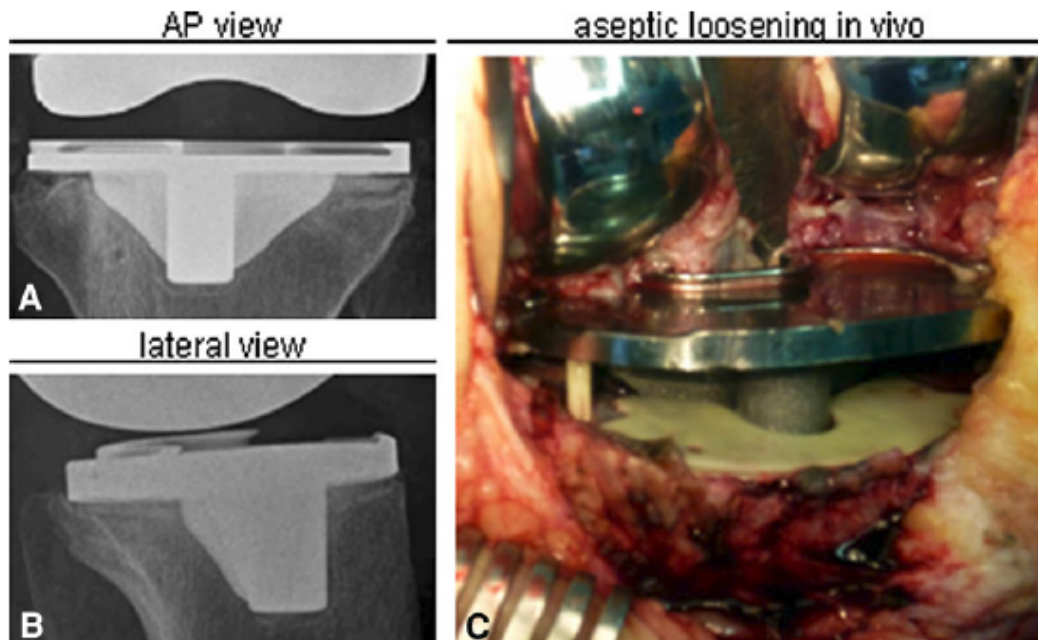
Figure 1: A–C Conventional (A) AP and (B) lateral view radiographs of a short-keeled TKA show apparent radiolucency. (C) Failure at the implant-cement interface was noticed in four of the five revision cases. Note the debonding and remodeling. The tibial tray is a thinner Ti6Al4V alloy and the stem is not long. The lucency in this case is not due to stress shielding. (Reis et al.¹²)

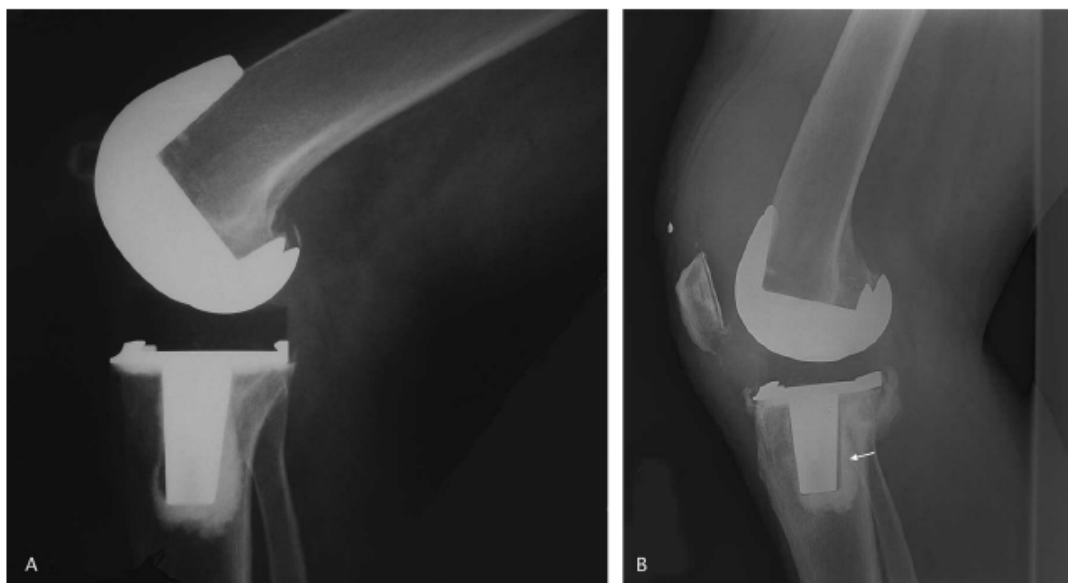
Figure 2: A) The 6-week postoperative radiograph showed good alignment and fixation of the components although a linear defect in the cement mantle was present along the anterior tibial peg. (B) A lateral radiograph obtained 2 years after surgery shows tibial component loosening with debonding between the tibial baseplate and surrounding cement mantle (arrow). The posterior portion of the tray appears to have a defect because of the rotational position of the radiograph. (Cheng et al.¹³)

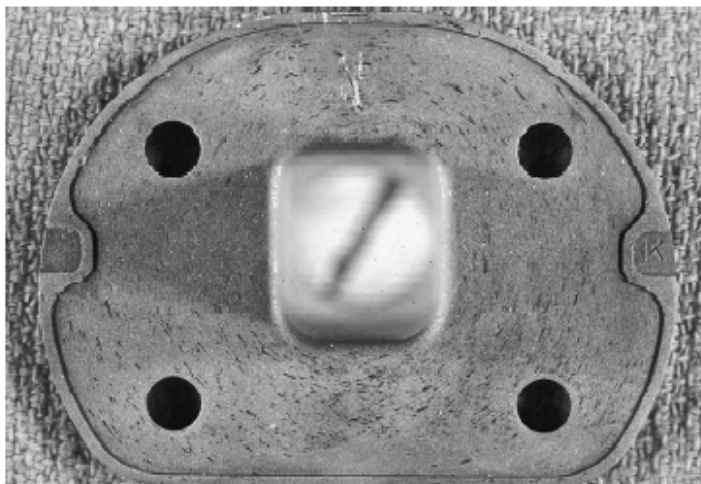
Figure 3: A photograph shows the undersurface of the tibial baseplate. There is a circular pattern of abrasive scratches, indicating the implant debonded and rotated in the cement mantle. (Cheng et al.¹⁴)

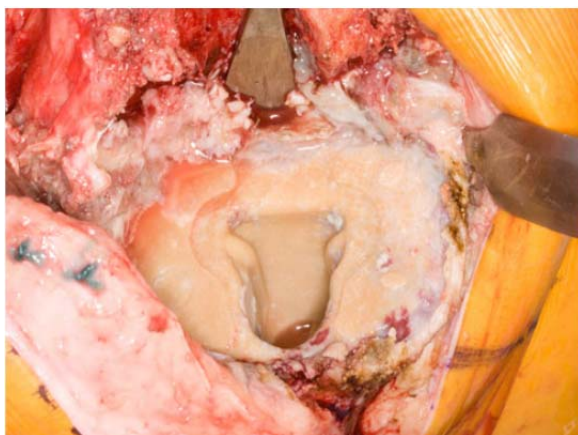
Figure 4: Debonding of the tibial component leaves behind a nearly intact cement mantle attached to the proximal tibia. (Arsoy et al.¹⁶)

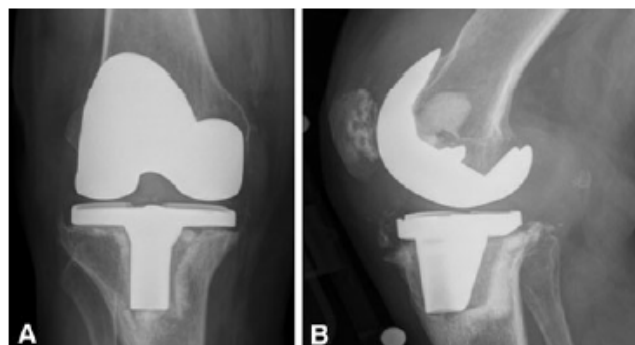
Figure 5 A-B: The AP view (A) reveals a pronounced varus position of the tibial tray. The lateral view (B) demonstrates flexion subsidence with debonding at the cement-prosthesis interface. (Arsoy et al.¹⁷)

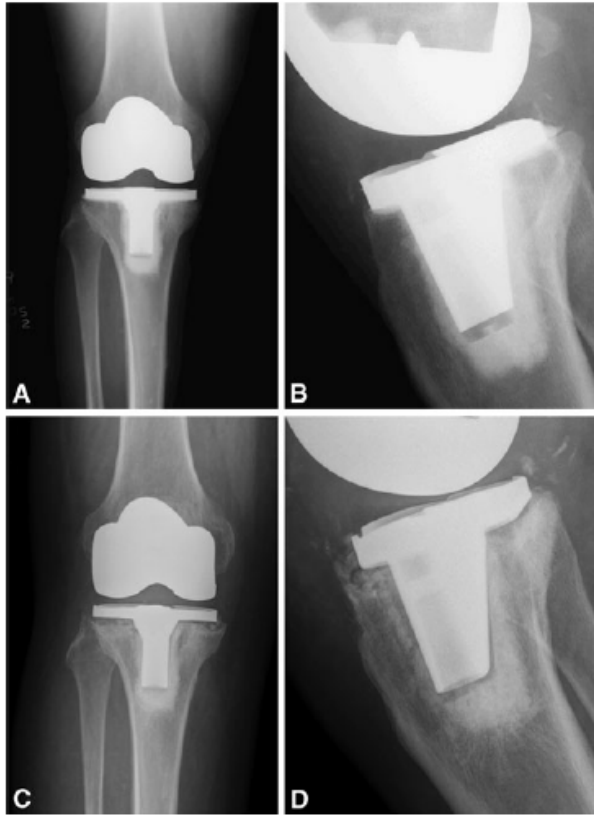
Figure 6 A–D: (A) Anterior and (B) posterior radiographs of a patient with an asymptomatic TKA at 24 month postoperatively. There are radiolucent lines present underneath the tibial tray. (C–D) Nine months later the patient presents with radiographs showing debonding of the tibial component. (Arsoy et al.¹⁸)

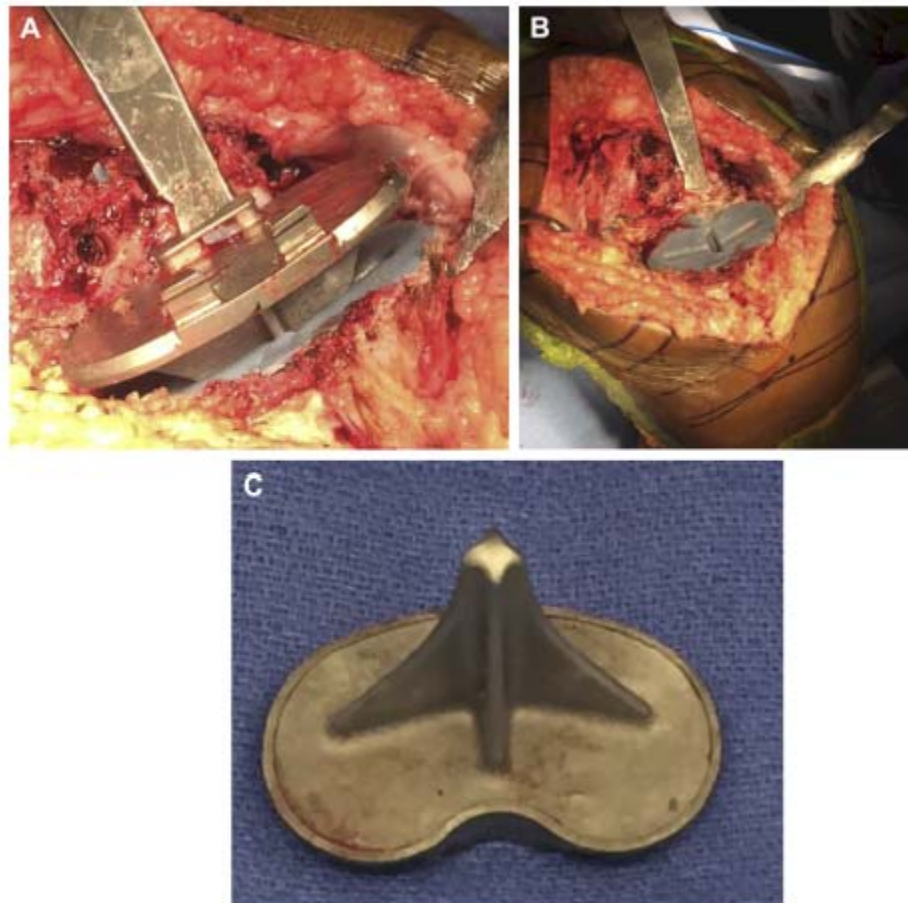
Figure 7: (A) Tibial baseplate being elevated off of the tibial surface and the cobalt cement mantle. (B). Intraoperative image of the proximal tibia with the remaining intact cobalt cement-bone interface. (C) Extracted tibial baseplate at the time of revision surgery. The component demonstrates no adherence of cement to undersurface of the tray. (Kopinski et al.²⁴)

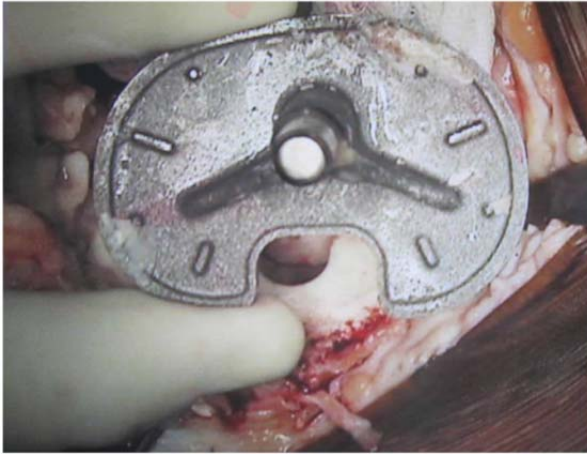
Figure 8: Cement–implant interface. This photograph was taken at the time of revision surgery demonstrating the complete absence of cement on the tibial tray. The tibial tray was grossly loose at the time of revision and easily removed.(Hazelwood et al.³⁰)

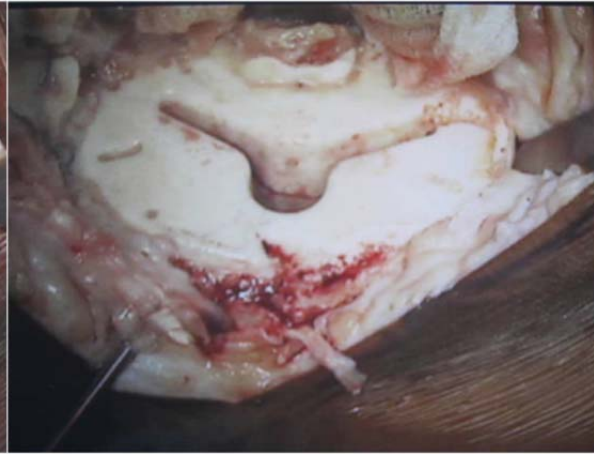
Figure 9: Cement–bone interface. Intraoperative photo taken at the time of revision demonstrating an intact cement–bone interface of the proximal tibia. (Hazelwood et al.³¹)
